Inspection Report

DAN MOULTON

Type: ROUTINE INSPECTION

Date: 25-SEP-2019

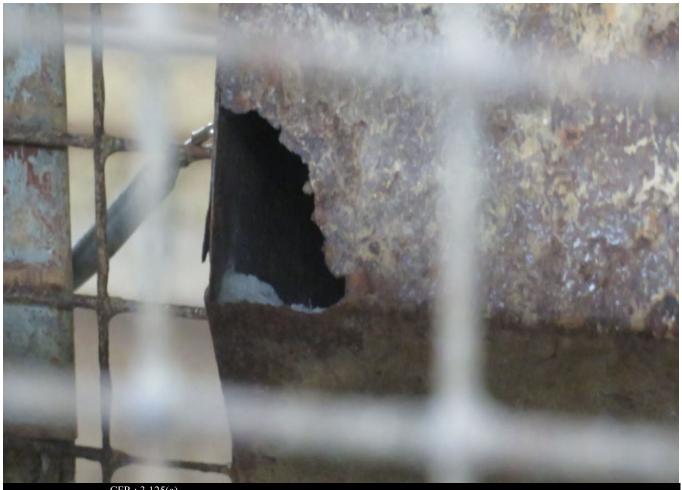
- -Three enclosures had holes in the floor with points exposed to the chinchillas. Some holes were large enough they could potentially get out. Note: The licensee moved the animals in these enclosures to other enclosures that did not have holes and points in them during the inspection.
- -A young chinchilla was seen going through a hole in the feeder area into the neighboring enclosure. The young chinchilla went back to its mother and then the licensee repaired the hole to securely contain it.
- -Multiple dust boxes had rust and rough edges; the licensee replaced 4 of the worst affected during inspection.
- -Most of the feeders front edges have rusted to the extent that rough and sharp edges are exposed to the chinchillas.

Close-up of rusted hole in dust box with edges exposed to animal.

Holes in enclosures, sharp points, and rusted dust boxes and feeder edges could cause injury to the chinchillas. Ensure that items and enclosures are repaired or replaced to protect the health of the chinchillas.

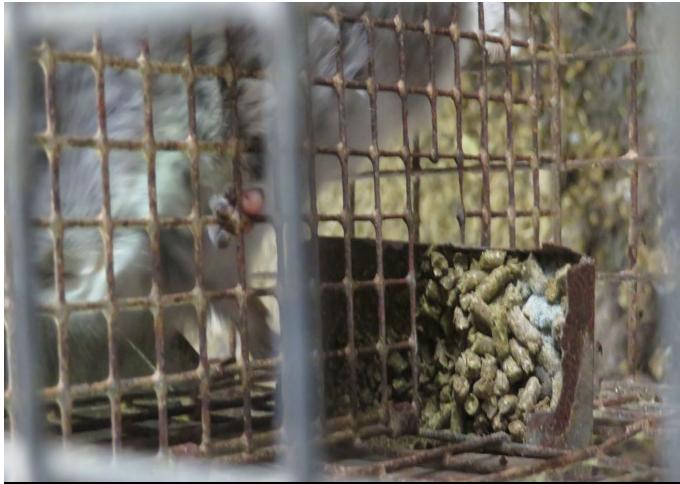
Feeder with rusted and rough edges; similar to most of feeders in facility.

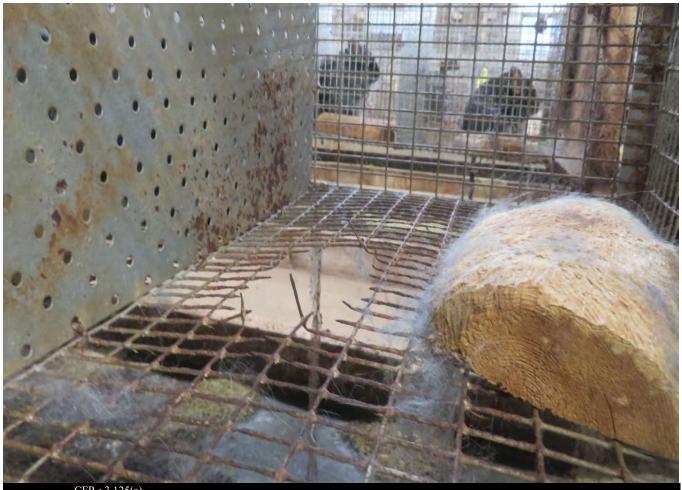
Broken wires in enclosure floor that was housing chinchilla during inspection (licensee immediately moved chincilla to a safe enclosure).

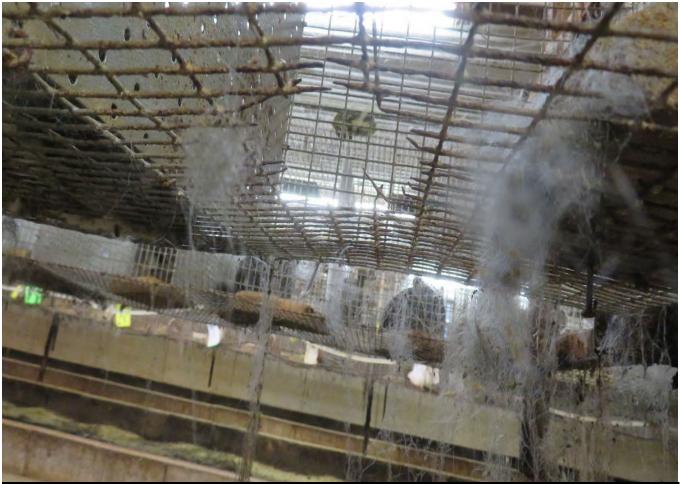
Looking up at broken wires in enclosure floor that was housing chinchilla during inspection (licensee immediately moved chincilla to a safe enclosure).

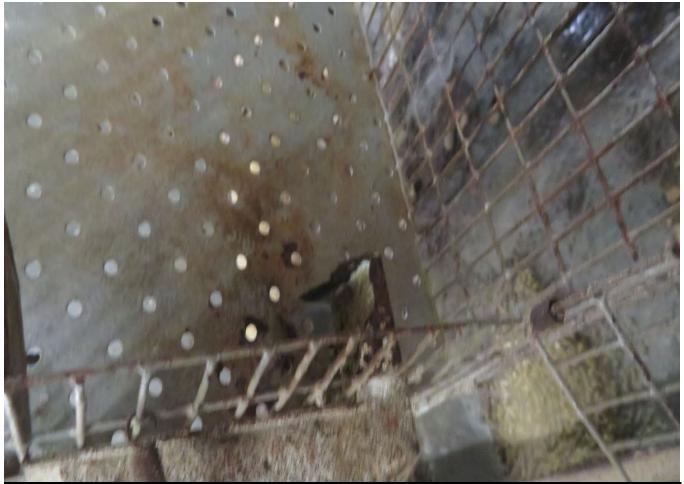
Feeder with rusted and rough edges; similar to most of feeders in facility.

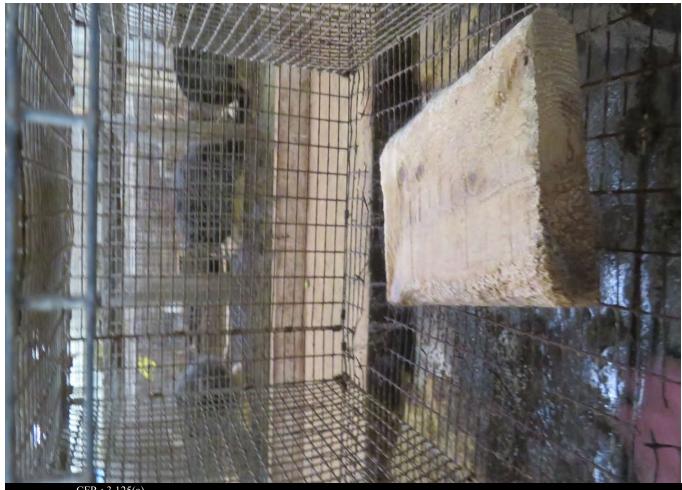
Broken wires in back part of enclosure floor and by block that was housing chinchilla during inspection (licensee immediately moved chincilla to a safe enclosure).

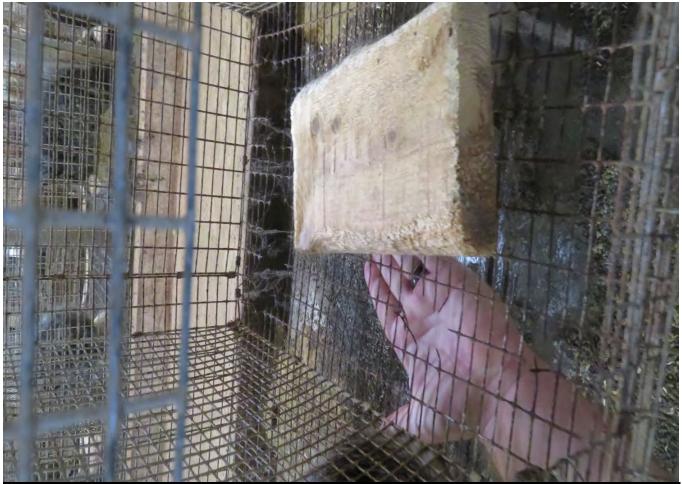
Broken wires in enclosure floor that was housing chinchilla during inspection

(licensee immediately moved chincilla to a safe enclosure).

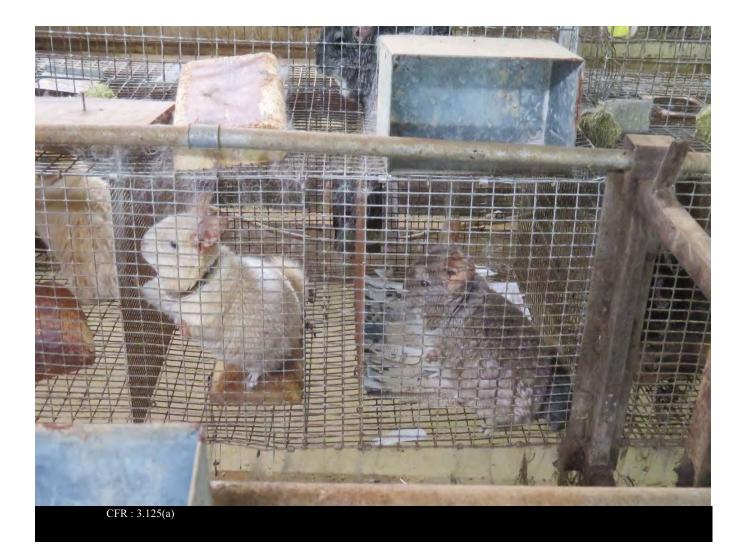
Description: Grey chinchilla mother on right (43A) had young chinchilla that was crossing over

to white chinchilla on left (43B) through hole by feeder.

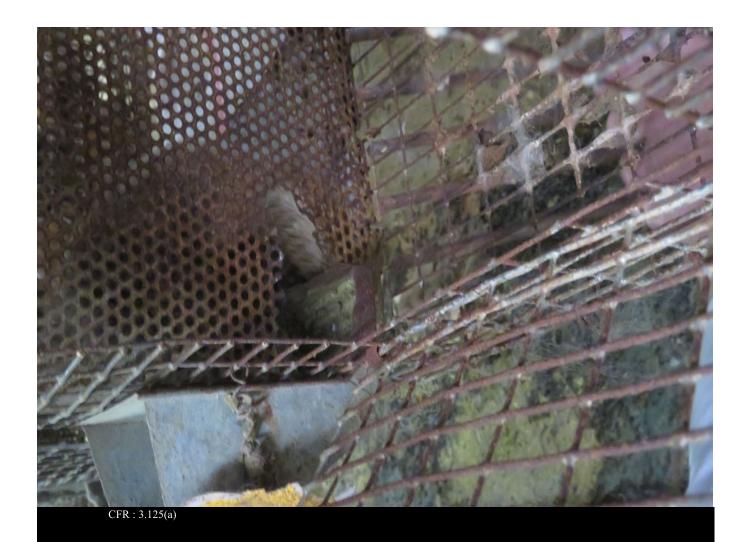
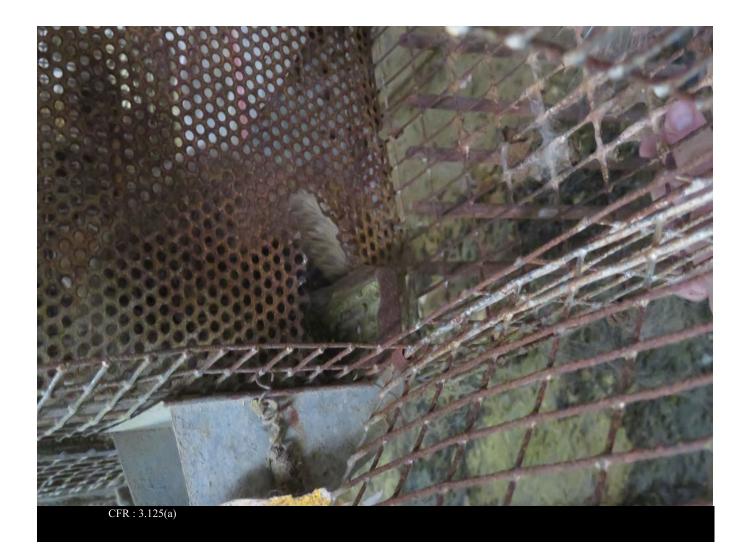
Hole that young chinchilla was using to go through feeder area to neighboring enclosure.

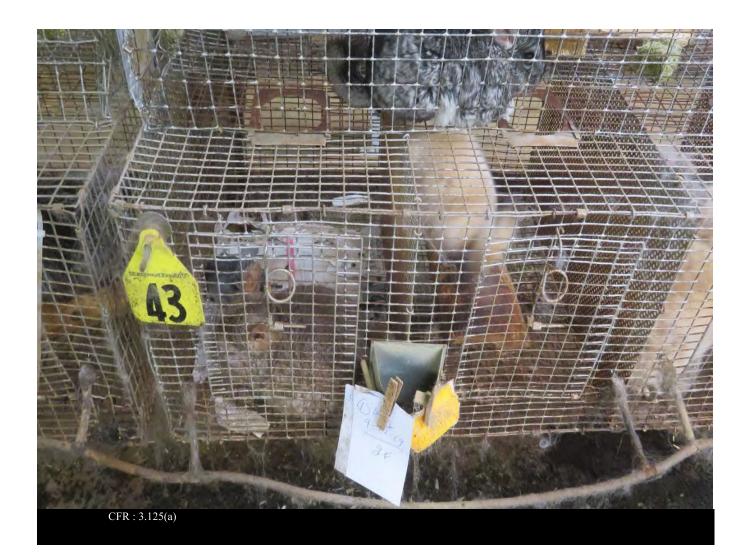
Mother chinchilla 43A with young chinchilla and 43B; young was passing over through feeder hole to 43B. Young went back with mother and then licensee patched hole during inspection.

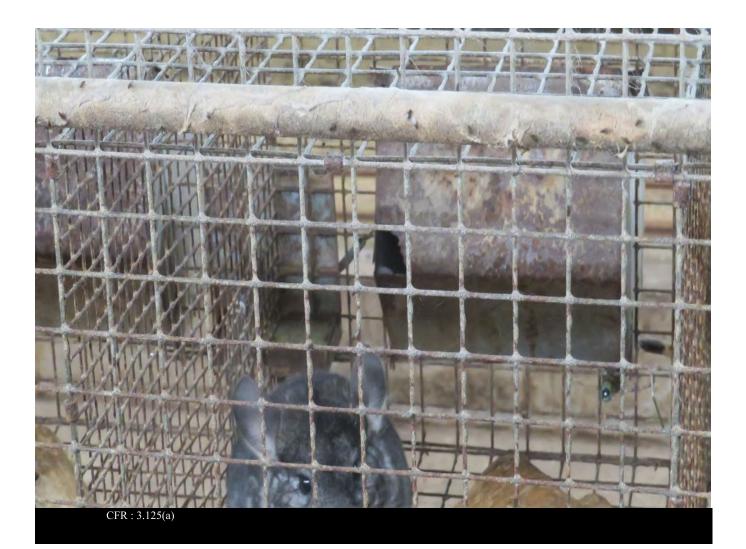
Rusted hole in dust box with edges exposed to animal.

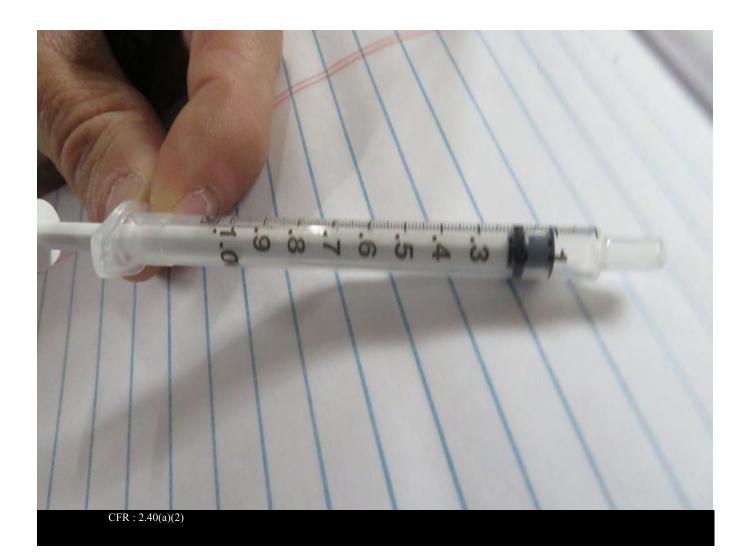
Authority of attending veterinarian: The current treatment protocol for eye infection and abscess problems with oxytetracycline was obtained from a consulting veterinarian that does not visit the facility. The dose and frequency being used do not match the written literature that the facility has on hand. We contacted the local veterinarians that visit the facility and could not verify that the current dose and frequency in use (which is less than the literature recommendation) is adequate for the conditions being treated. The licensee must ensure that the attending veterinarian that has formally agreed to make regularly scheduled visits to the facility is aware of consultant recommendations and prior to beginning consultant-recommended medications the attending veterinarian has been given the authority to oversee the treatment of the animals at the facility.

Syringe licensee showed us that uses for oxytetracycline, said gives each affected animal '1' which is 0.1 mL on these syringes. Licensee said that they treat on Saturdays. Also at one time said they sometimes they treat every other day.

Correction: Work with the attending veterinarian and obtain and follow clear treatment instructions for the oxytetracyline and ensure that treatment protocols are approved by the attending veterinarian.

Correct and clarify prior to further use of oxytetracycline.

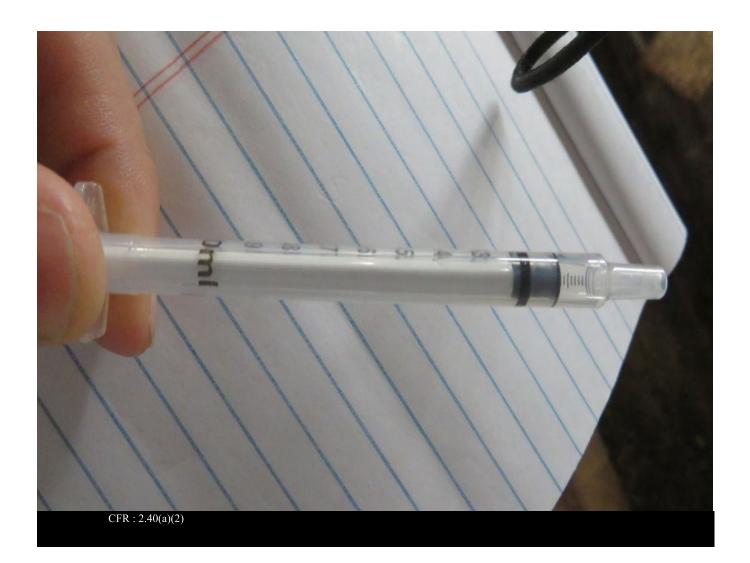
Syringe licensee showed us that uses for oxytetracycline, said gives each affected animal '1' which is 0.1 mL on these syringes.

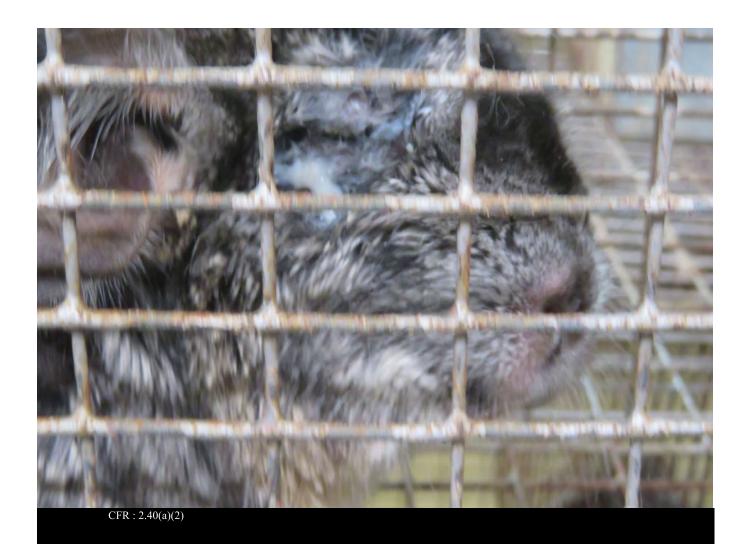
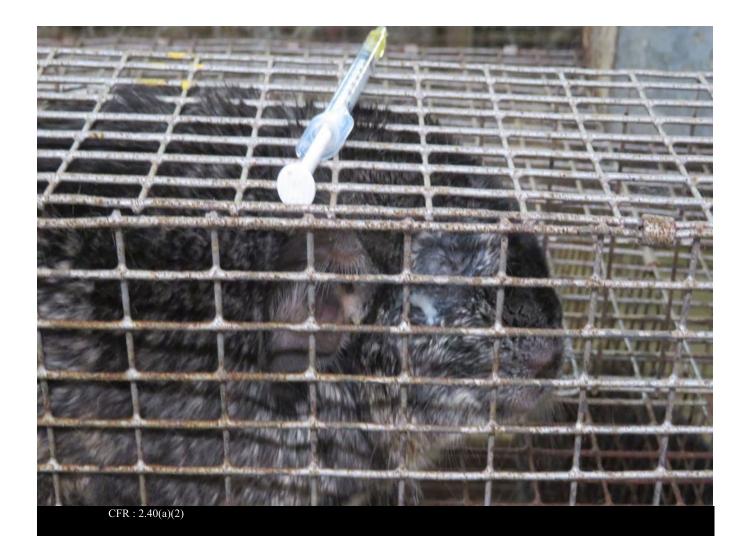
Male that we observed licensee treat; it was given about 0.1 mL Oxytet 100 orally.

(animal has been on treatment protocol for undetermined amount of time).

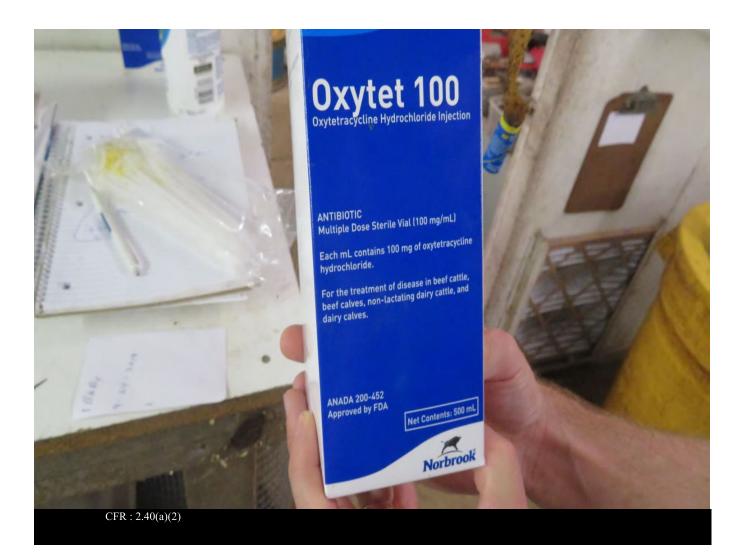
Product that facility has on hand and has been giving orally to chinchillas, reports giving 0.1 ml/cc once every Saturday or once every other day.

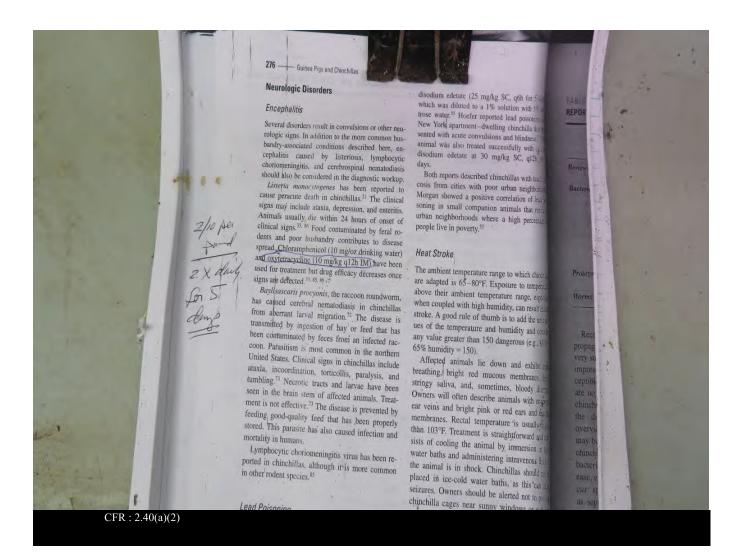
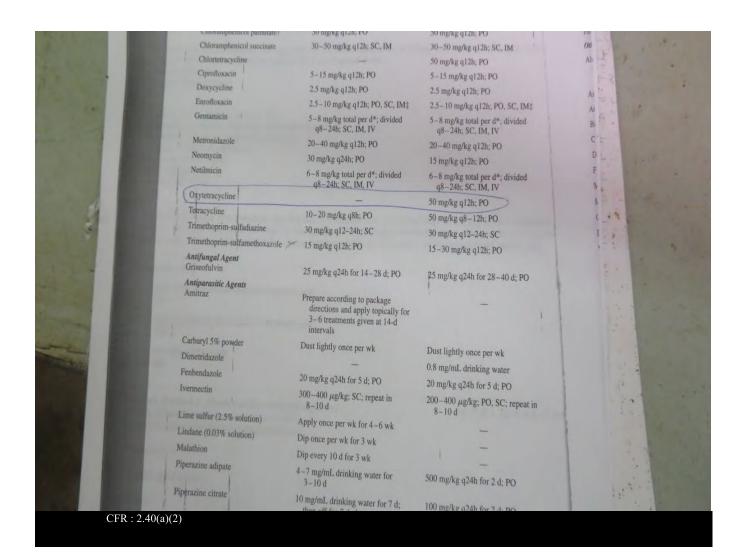
Textbook information that licensee thinks consulting veterinarian Dr. Feldman sent. Licensee said writing in margin might be his own. Recommended dose and frequency in literature provided doesn't match what facility protocol of giving about 10mg Oxytet by mouth once every 48h or every 7d.

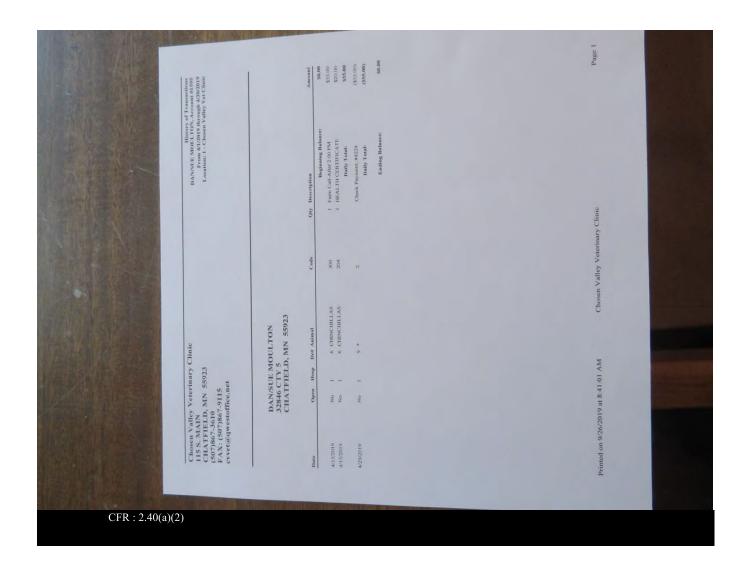
Local veterinary clinic that did the most recent walk-through at the facility, however said that oxytet was discussed but a clear protocol wasn't established.

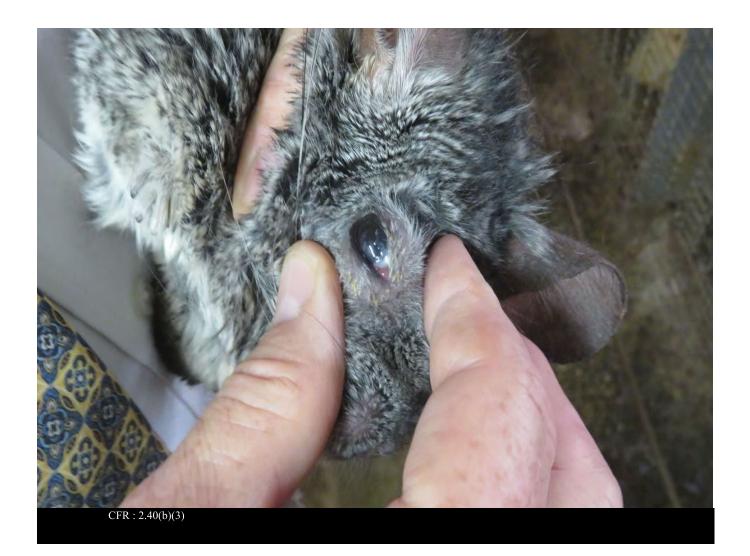
- -Four chinchillas had eye problems that had not been noticed previous to inspection. They had squinting eyes, mild swelling and some pale discharge and some had some crusting around the eye. The licensee added enclosure tags that indicate that these need to be on the treatment protocol. Ensure that daily observations are continually improved to find and treat these animals per the attending veterinarian's instructions.

Male that wasn't on treatment yet, its right eye was squinting and he had some

crusting and light discharge.

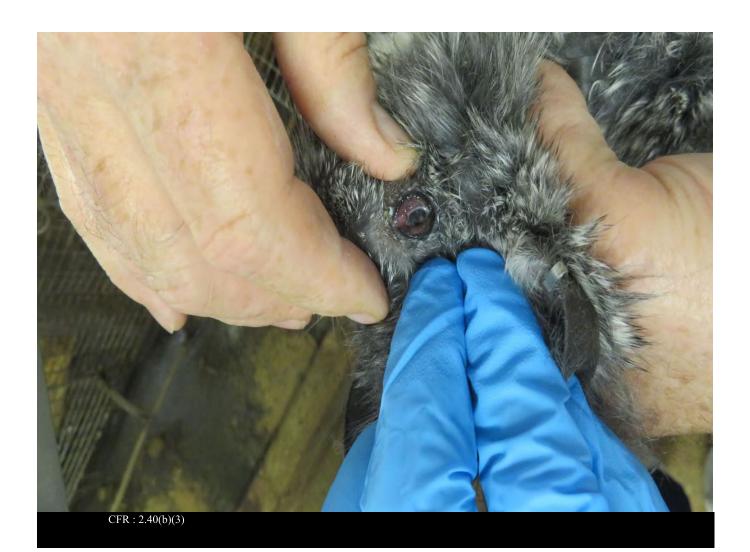
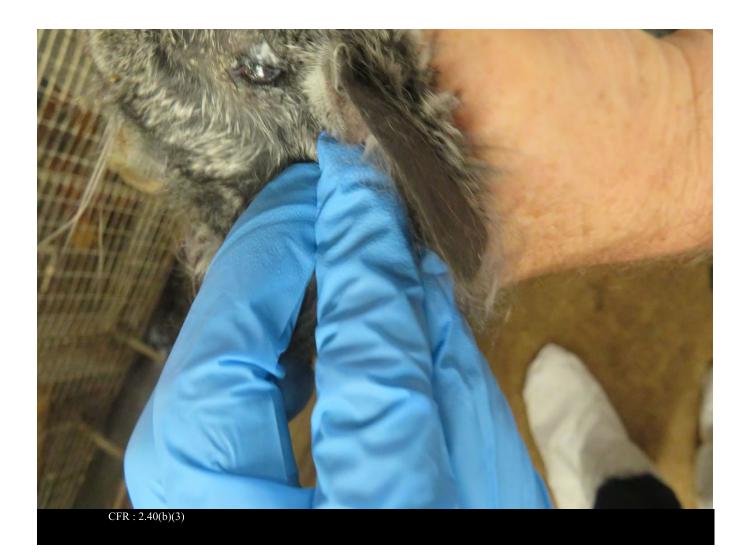
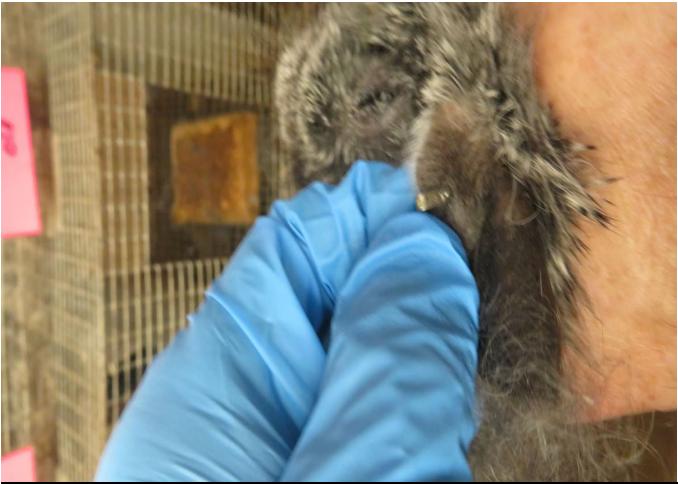
Female with eartag 805's right eye; not on treatment prior to inspection; right eye was squinting while in cage; mild discharge and crusting seen.

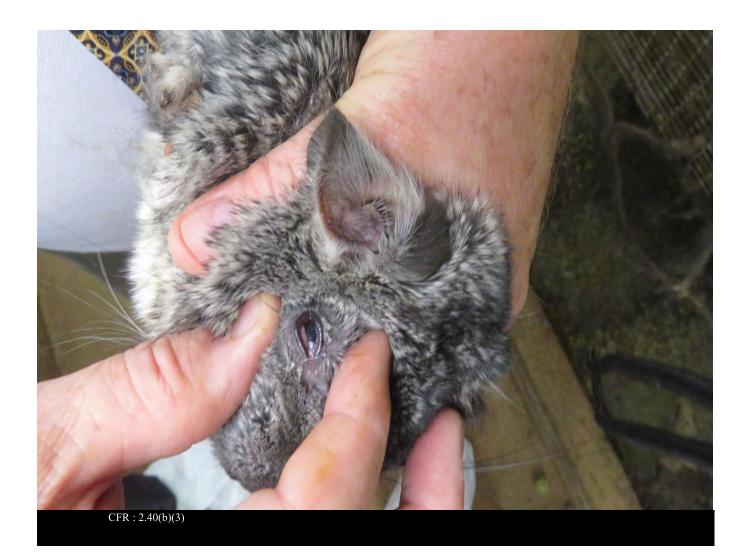
Male housed in 59; his right eye had some crusting and discharge. Wasn't on

treatment prior to inspection.

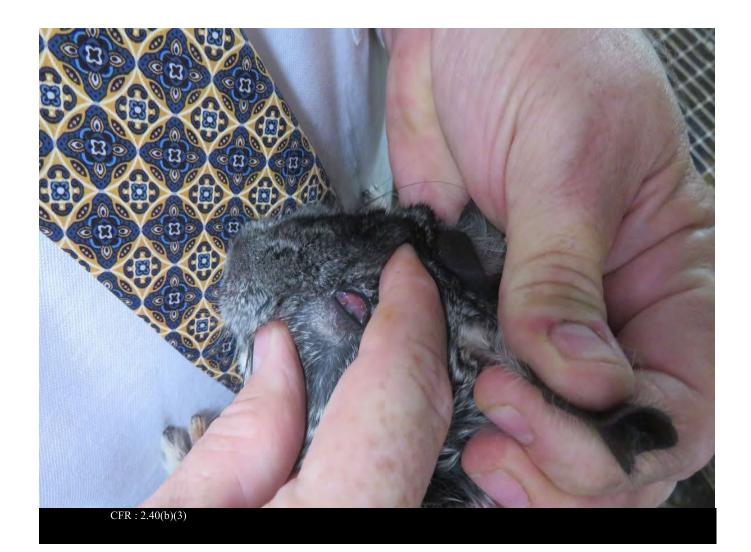
Male housed in 59; his left eye had some crusting and discharge. Wasn't on

treatment prior to inspection.

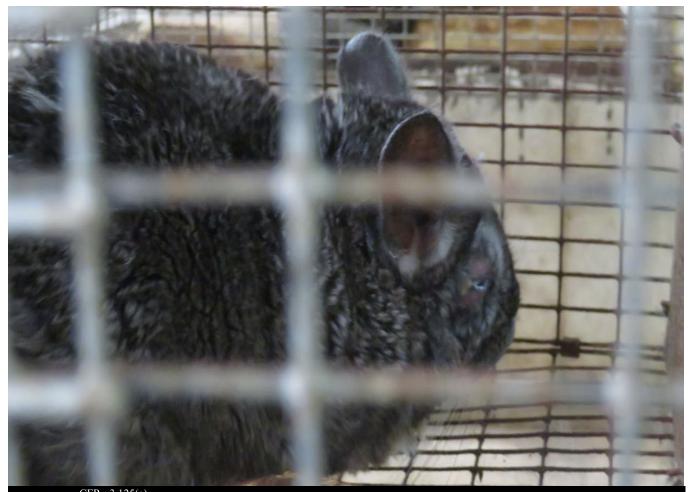
Description:Cageside observation of right eye on chinchilla in 39B that wasn't on treatment yet;

squinting, discharge and crusting present.

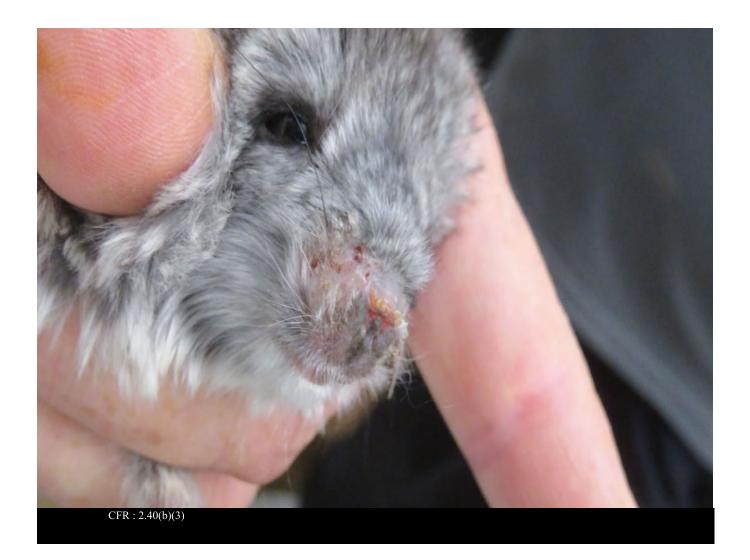
- -A juvenile chinchilla (the smaller of triplets housed in 78B) was missing hair on its nose and the skin had some scabs. This condition had not been identified by the facility and does not appear to be a recent injury/acquired condition and still needs to be communicated to the attending veterinarian to see if further evaluation or any treatment is needed. Ensure daily observations are improved to find and report these types of conditions to the attending veterinarian promptly.

Nose on juvenile (smaller one of triplets in 78B) that was had hair loss, crusting/scabs on nose; issue pointed out to licensee during inspection.

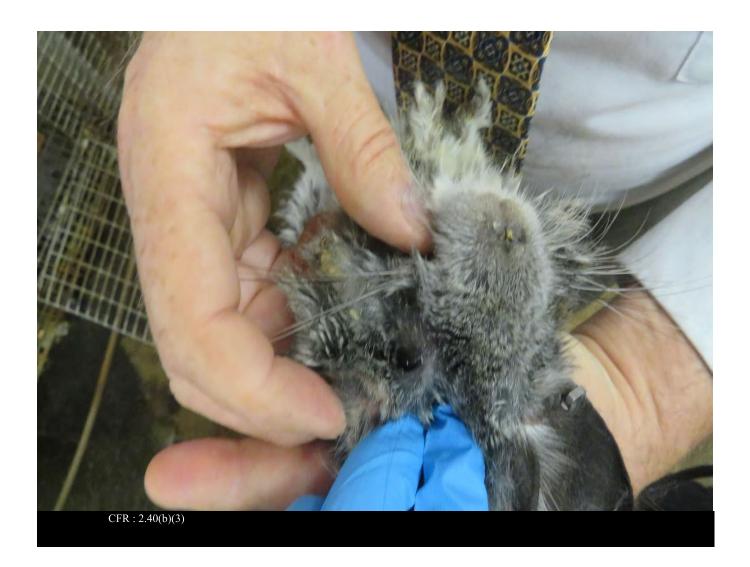
Female with ear tag 805's left eye; not on treatment prior to inspection; hair around

left eye had some crusting around it.

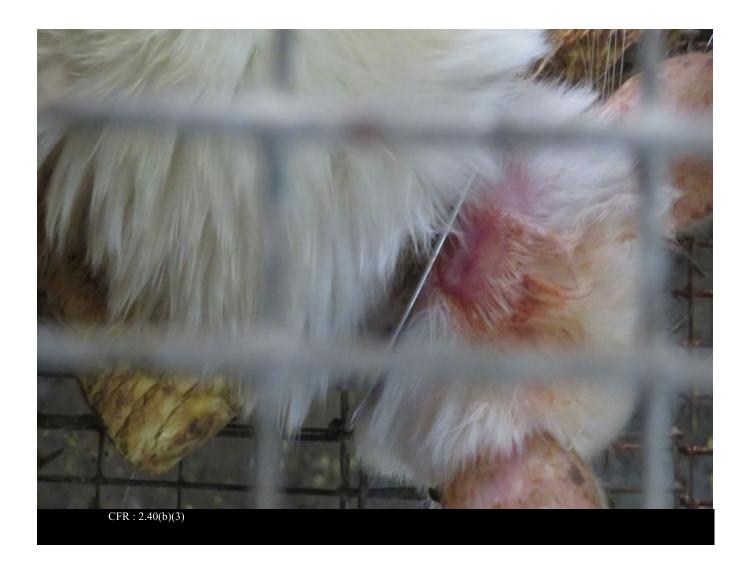
Female housed under tag 146A; close-up image during cageside observations prior

to confirming the collar was embedded.

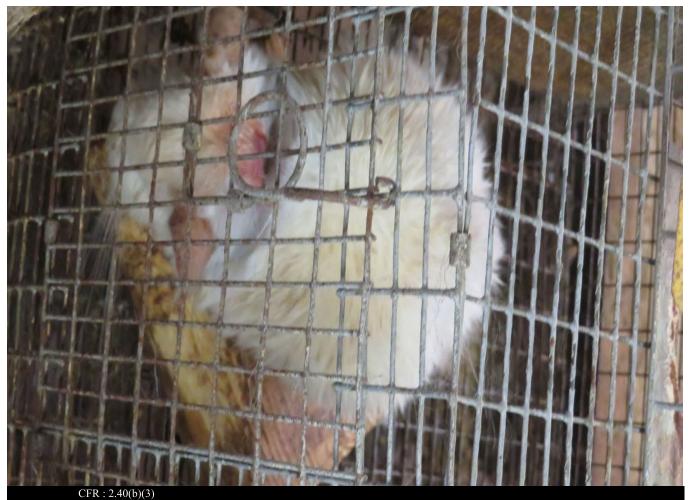
There were 29 animals that we observed that the facility had identified and were treating (mostly for eye conditions) prior to inspection; however there were four females (in enclosures 146A, 107A, 106C, and 119A) that had collars embedded in their neck tissue. The licensee removed their collars and the skin was eroded, there was matted hair and open lesions with visible redness and a pale liquid/granualar discharge that was seen in the lesions. These conditions were chronic serious conditions that were pointed out to the licensee during the inspection. The facility must have the attending veterinarian see these animals to ensure that proper treatment is given to prevent pain or worsening problems. A method of daily observations must be made that can prevent these type of collar injuries in the chinchillas.

Female housed under tag 146A; cageside observation prior to confirming that the collar was embedded; reddened area on top of neck is visible.

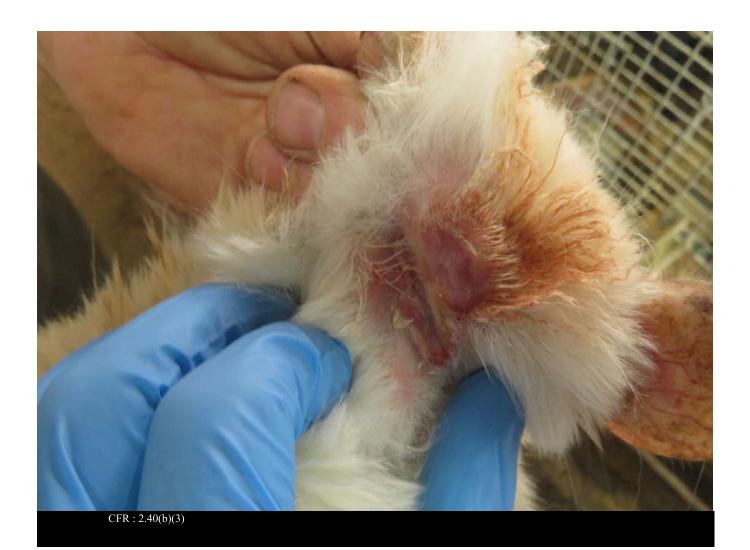
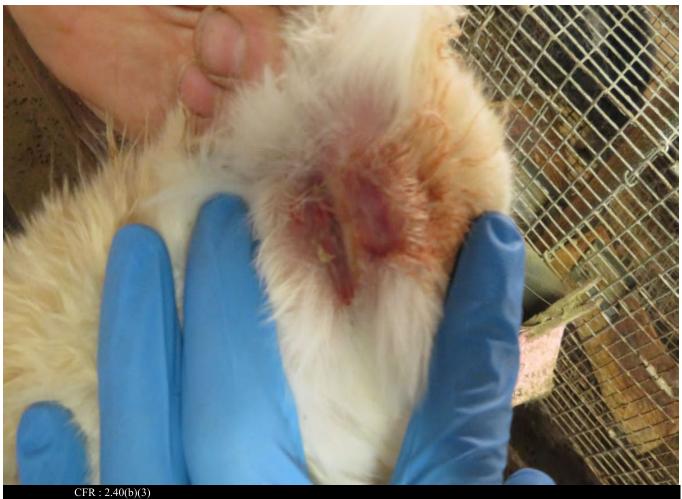
Description: Top of neck of female housed under tag 146A after embedded collar was removed,

eroded skin, discharge visible.

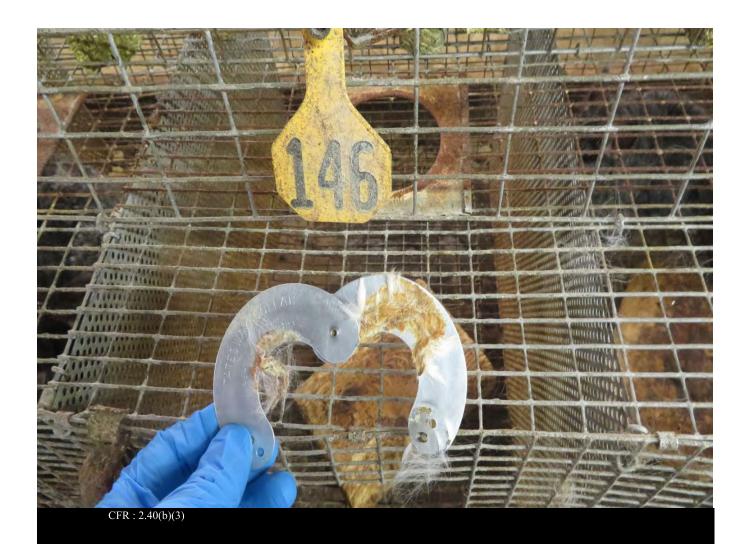
Embedded collar that was removed from female housed under tag 146A.

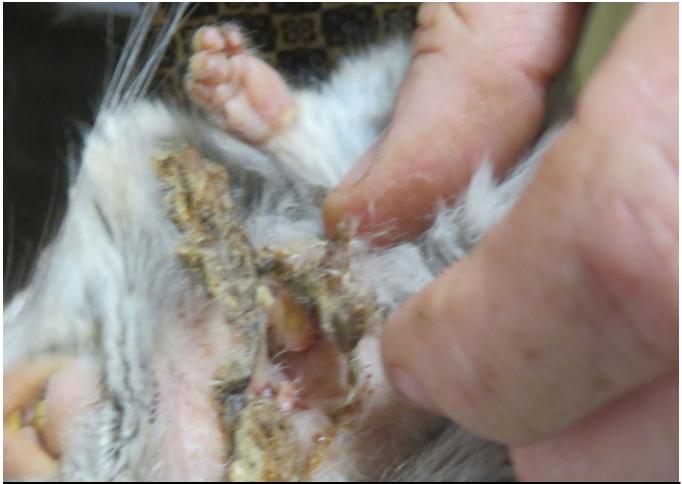
Area under neck on female chincilla housed in 107A, right after embedded collar removed by licensee; matted hair and eroded skin visible.

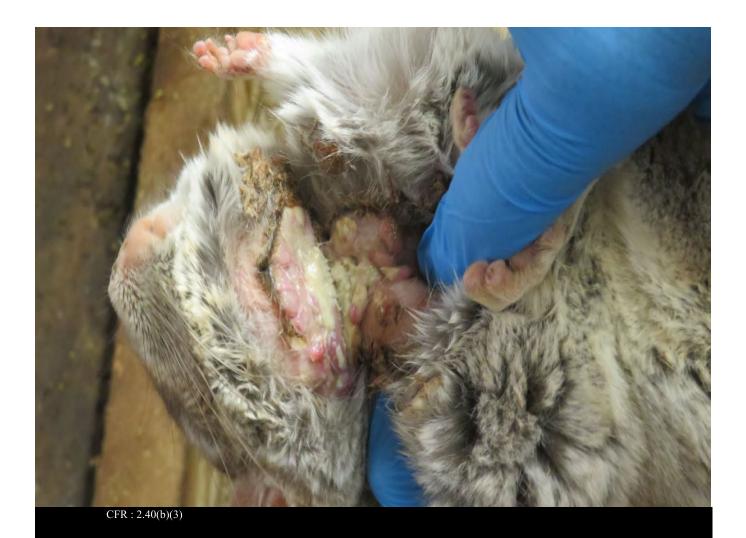
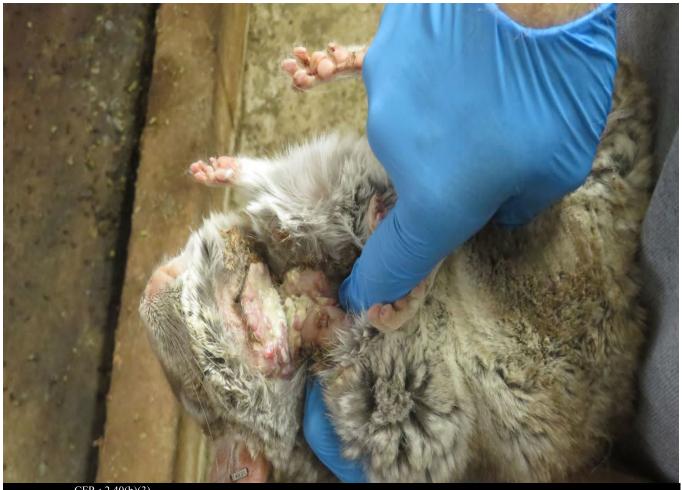
Area under neck on female chinchilla housed in 107A after embedded collar removed; matted hair, eroded skin, pale liquid and granular discharge visible with areas of reddened skin.

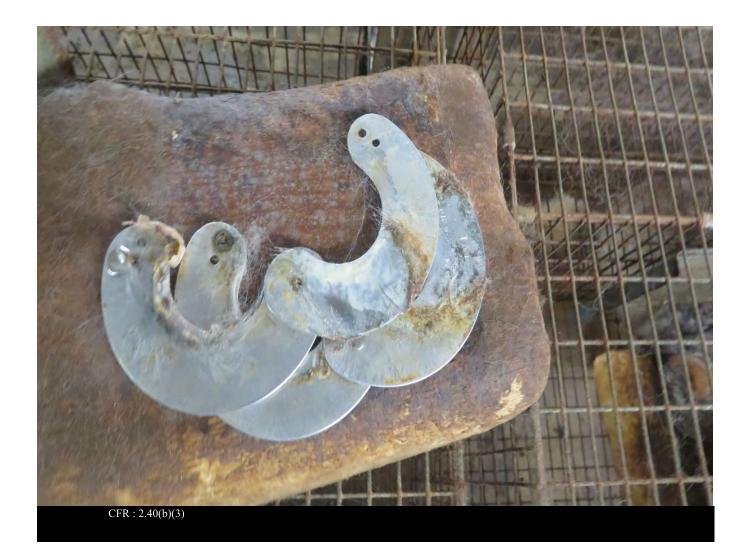
Collars removed from female chinchillas in 107A and 106C.

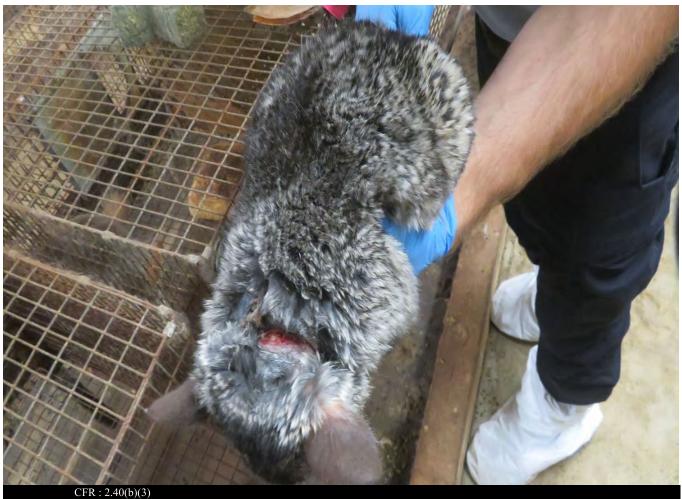
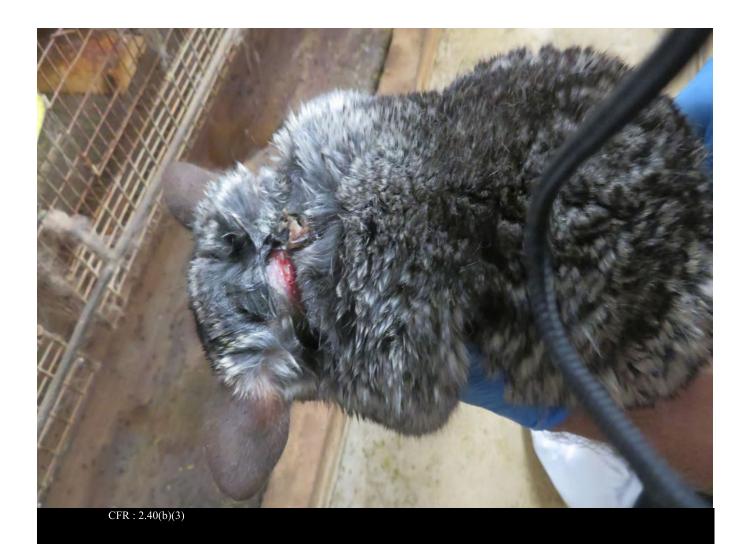
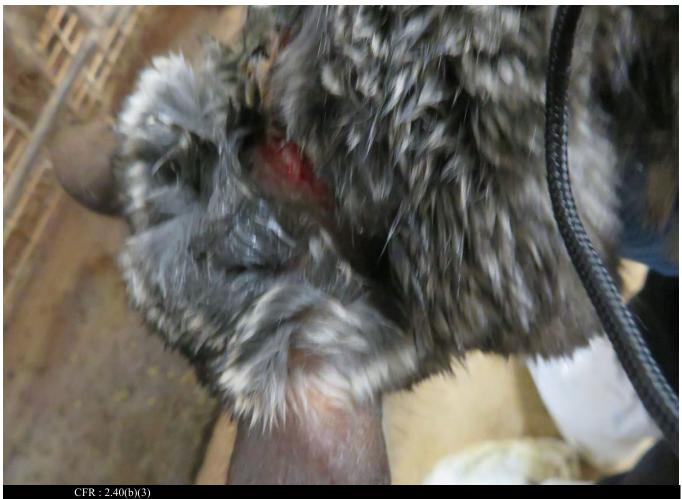
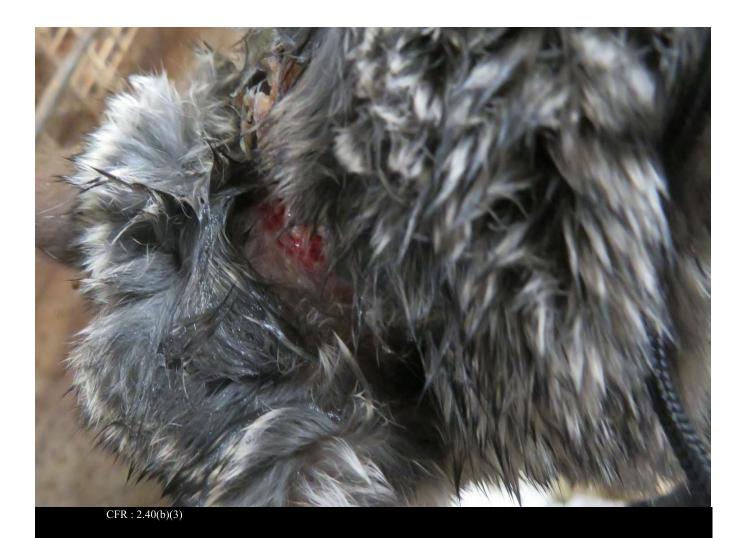
Female chinchilla housed in 106C after embedded collar removed; top of neck has eroded skin, matted hair, discharge and reddened areas.

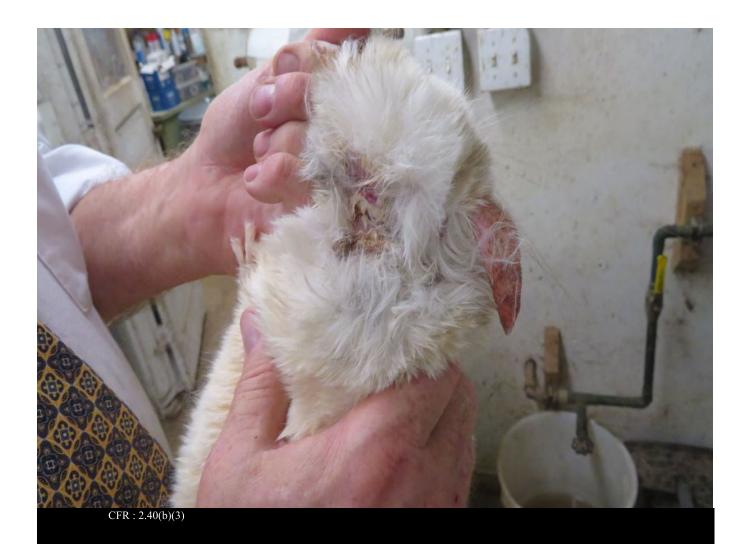
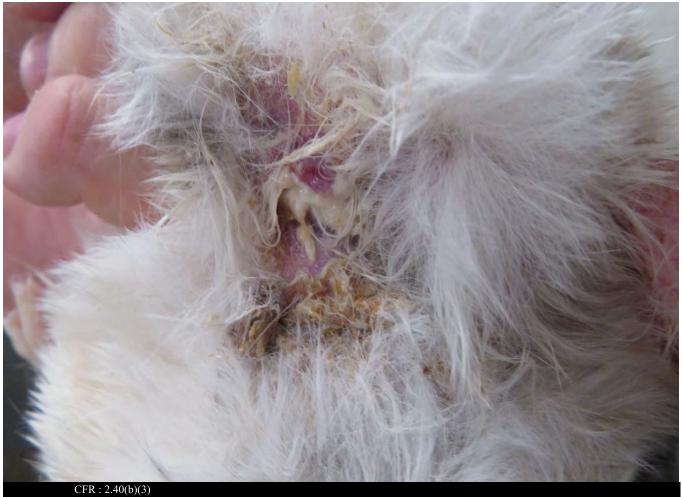
Top of neck of female chinchilla housed in 119A after collar was removed; area has matted hair, eroded skin, reddened skin and liquid/granular pale discharge.

VMO could note a putrid odor as well.

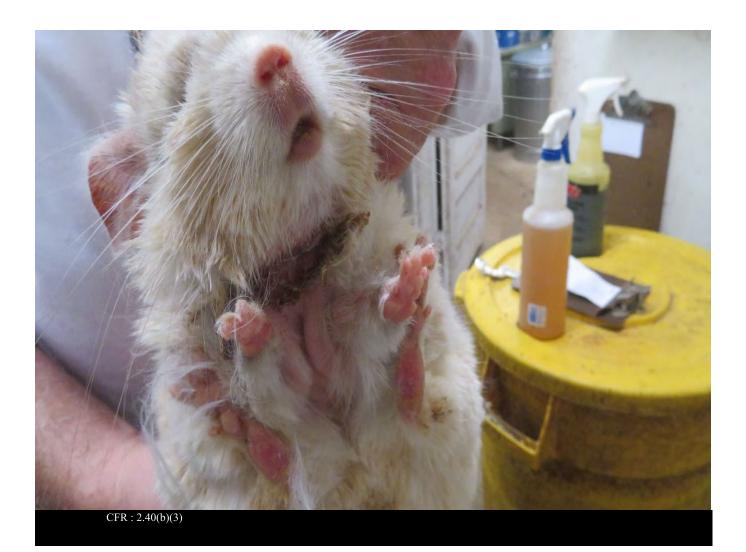
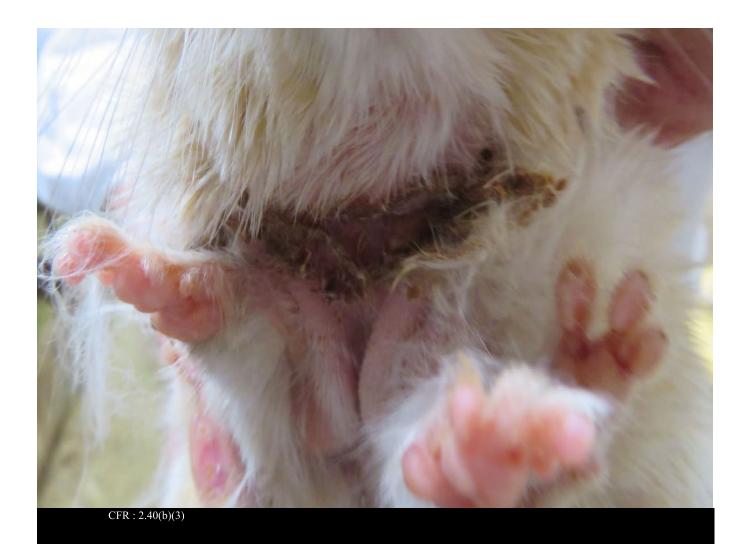
Bottom of neck of female chinchilla housed in 119A after collar was removed; matted hair, eroded skin seen. VMO could note a putrid odor as well.

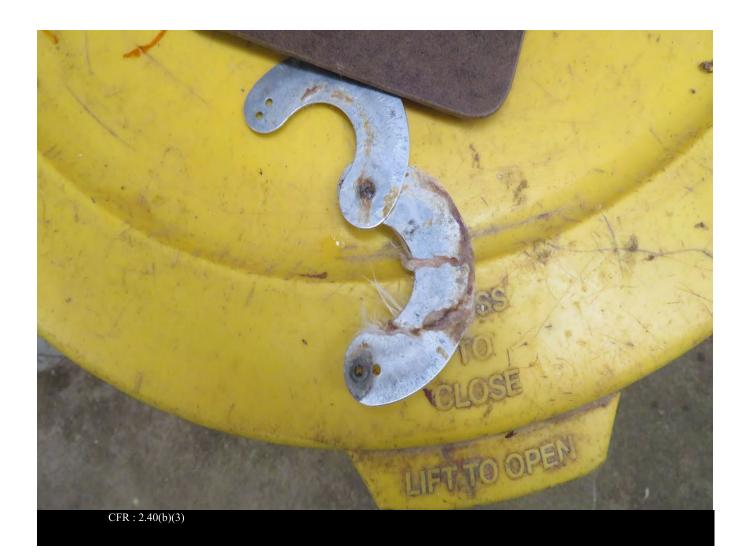
Collar that was on female housed in 119A.
